Photographic Log

Site Name:
Collierville High School

Tracking No.:
TN0081787

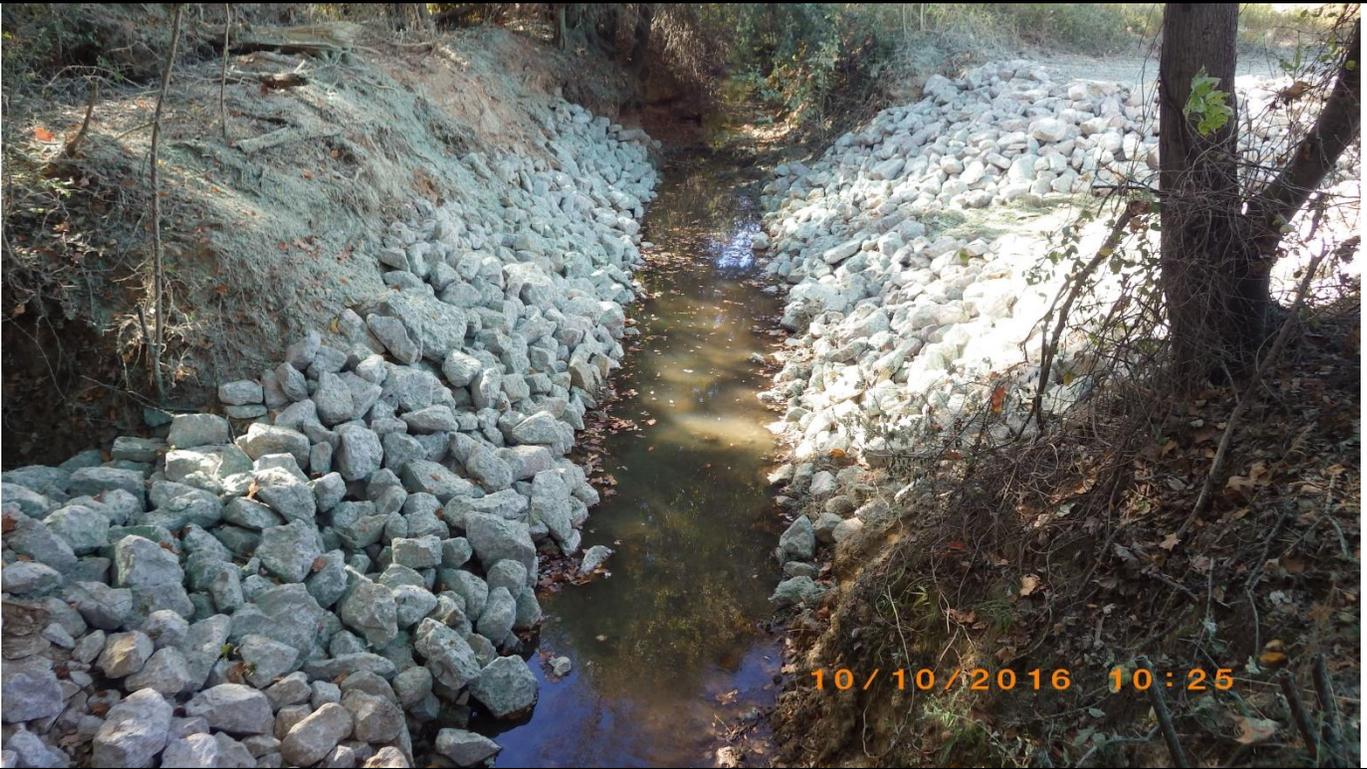
Photo 5. View looking upstream from Outfall SW7. Hydroseed was also observed on the rip-rap placed on the both banks of the unnamed tributary of Nonconnah Creek. The water in this portion of the unnamed tributary of Nonconnah Creek appeared fairly clear and had very little flow.

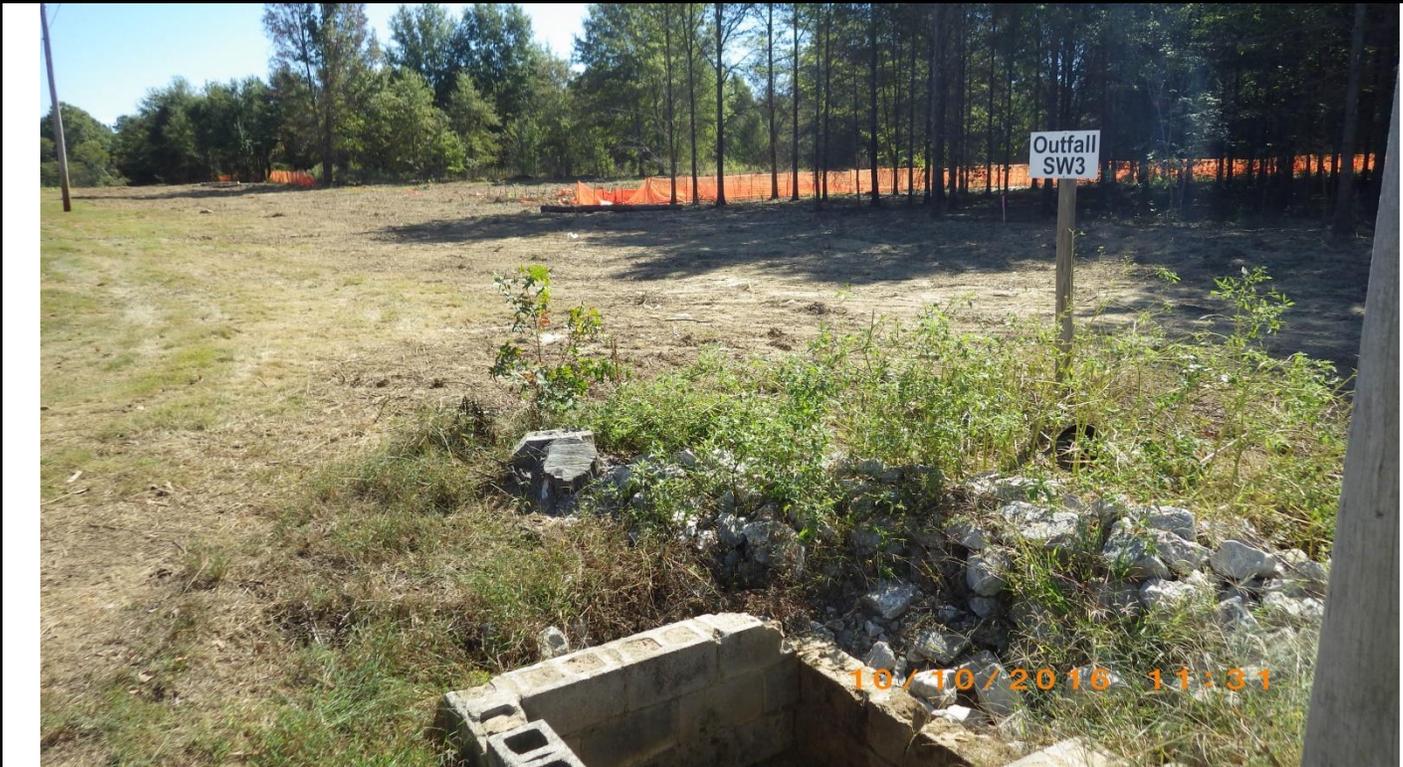
Photo 21. Sign identifying the approximate location of Outfall SW3.

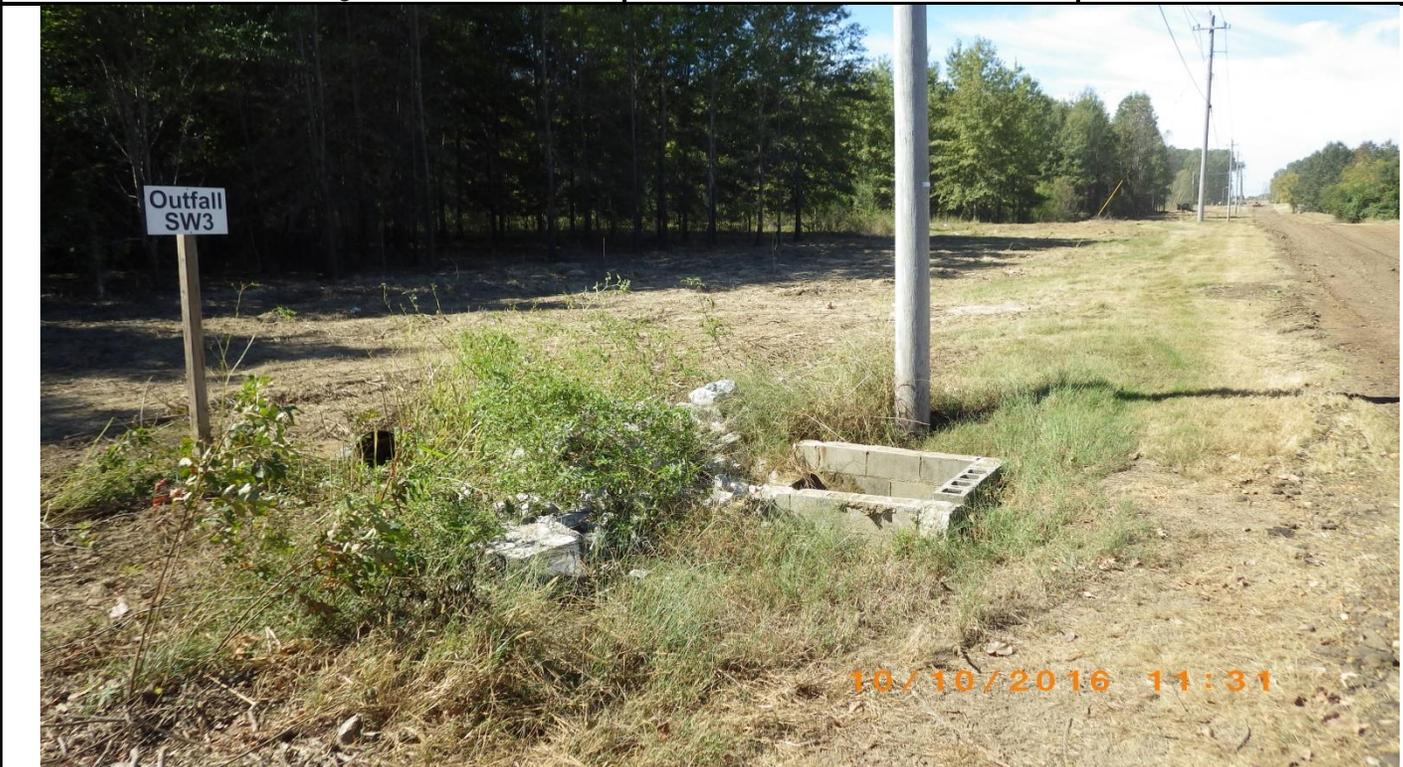
Photo 22. View looking east of Outfall SW3 at a cleared portion of the site. This area needs to be stabilized if construction activity will not occur within 14 days. The period of time that this area has been inactive was unknown at the time of the inspection.

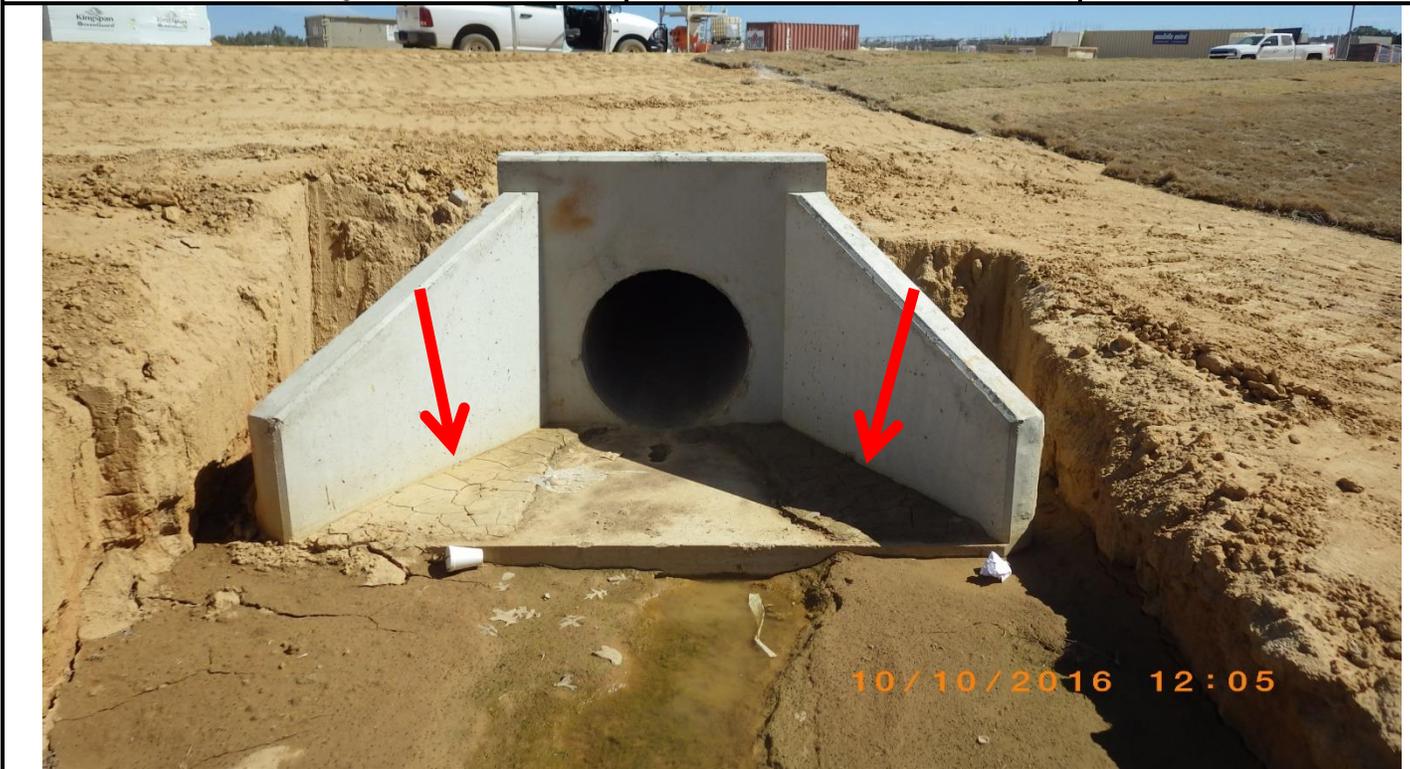
Photo 25. Dried sediment was observed on top of the storm drain inlet located near the drainage channel that discharges into the NW sediment basin. This indicates that sediment laden stormwater had pooled over the storm drain inlet at some point.

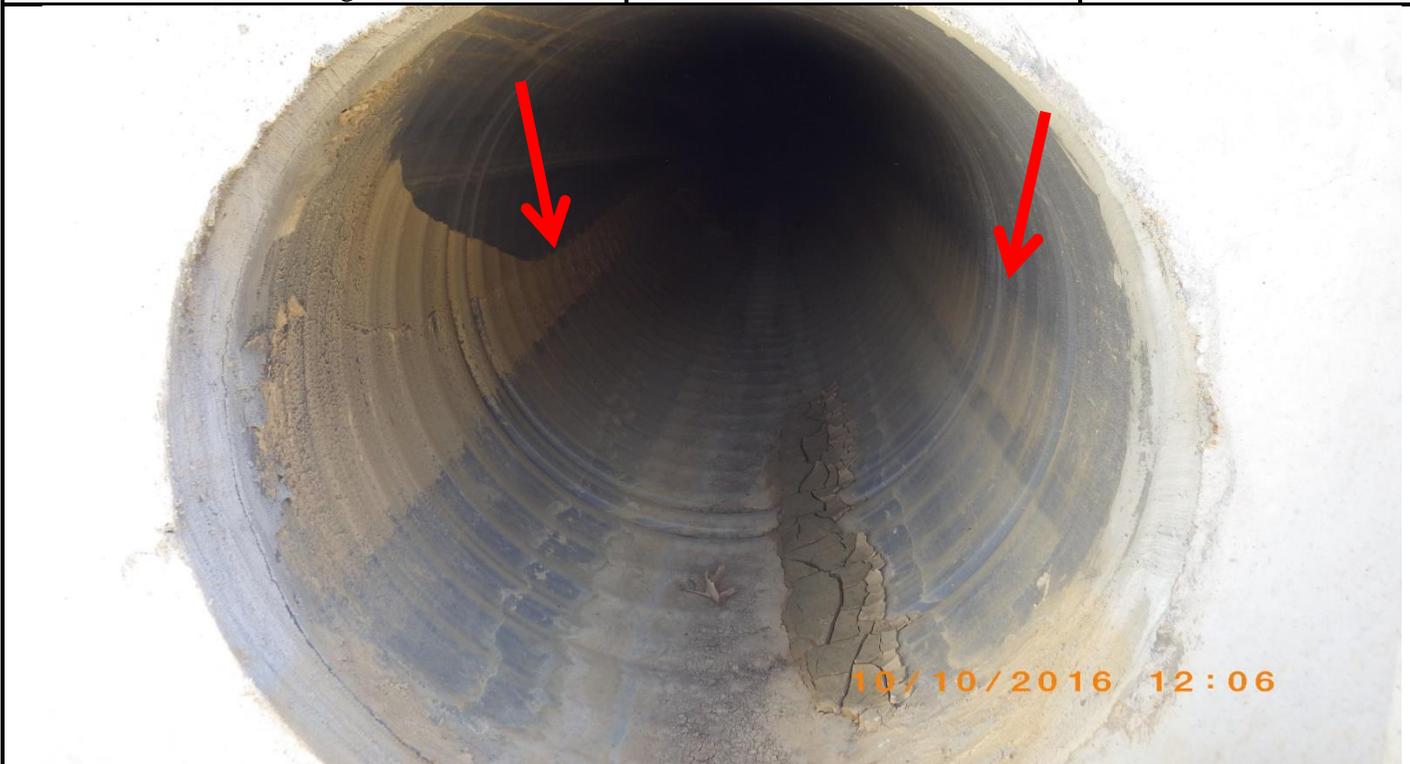
Photo 26. Sediment accumulation (red arrows) was observed on the outlet structure that discharges stormwater that enters the stormdrain inlet shown in Photo 25. This indicates that sediment has entered the stormdrain system and discharged at this location. This outlet structure discharges to a partly sodded channel that drains to the NW sediment basin.

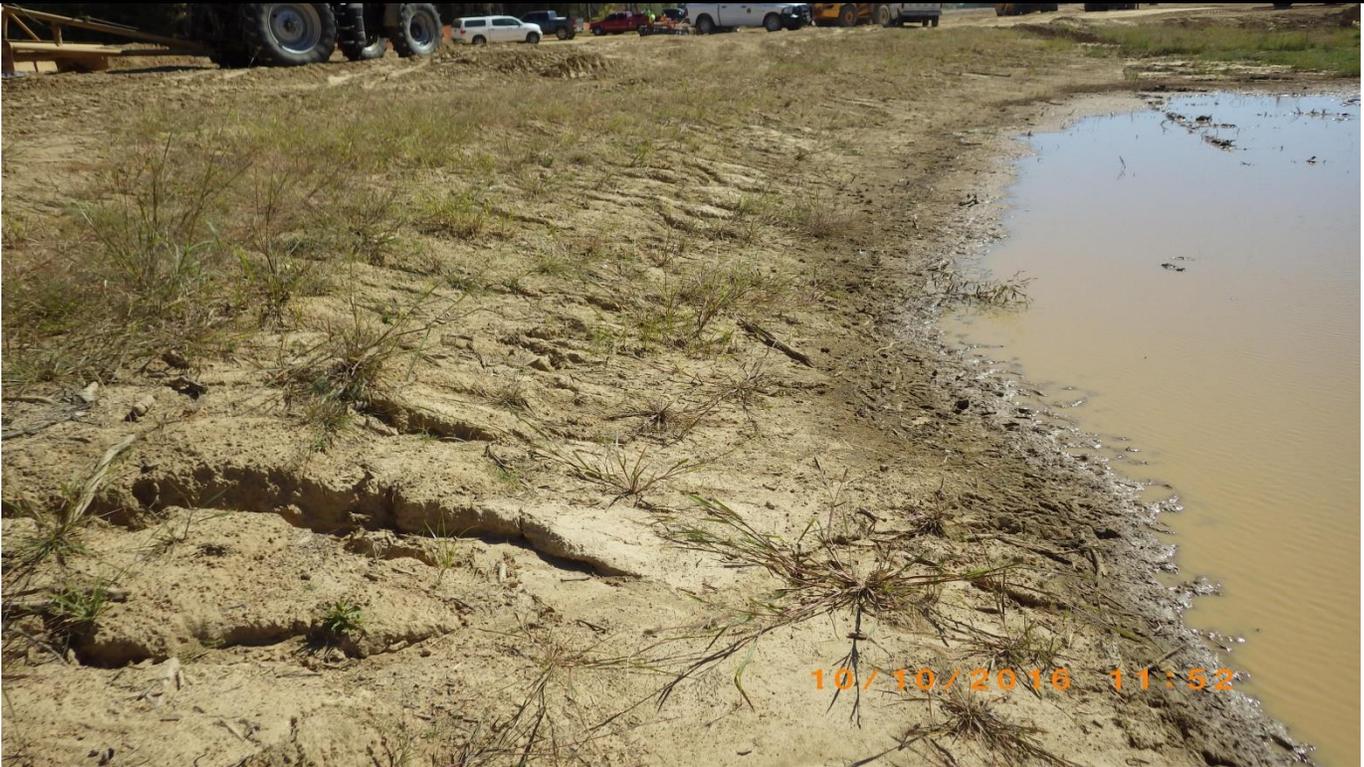
Photo 29. The NW sediment basin that discharges to Outfall SW1 appeared to have been completed and was holding water. The required water depth gauge within the basin had not been installed.

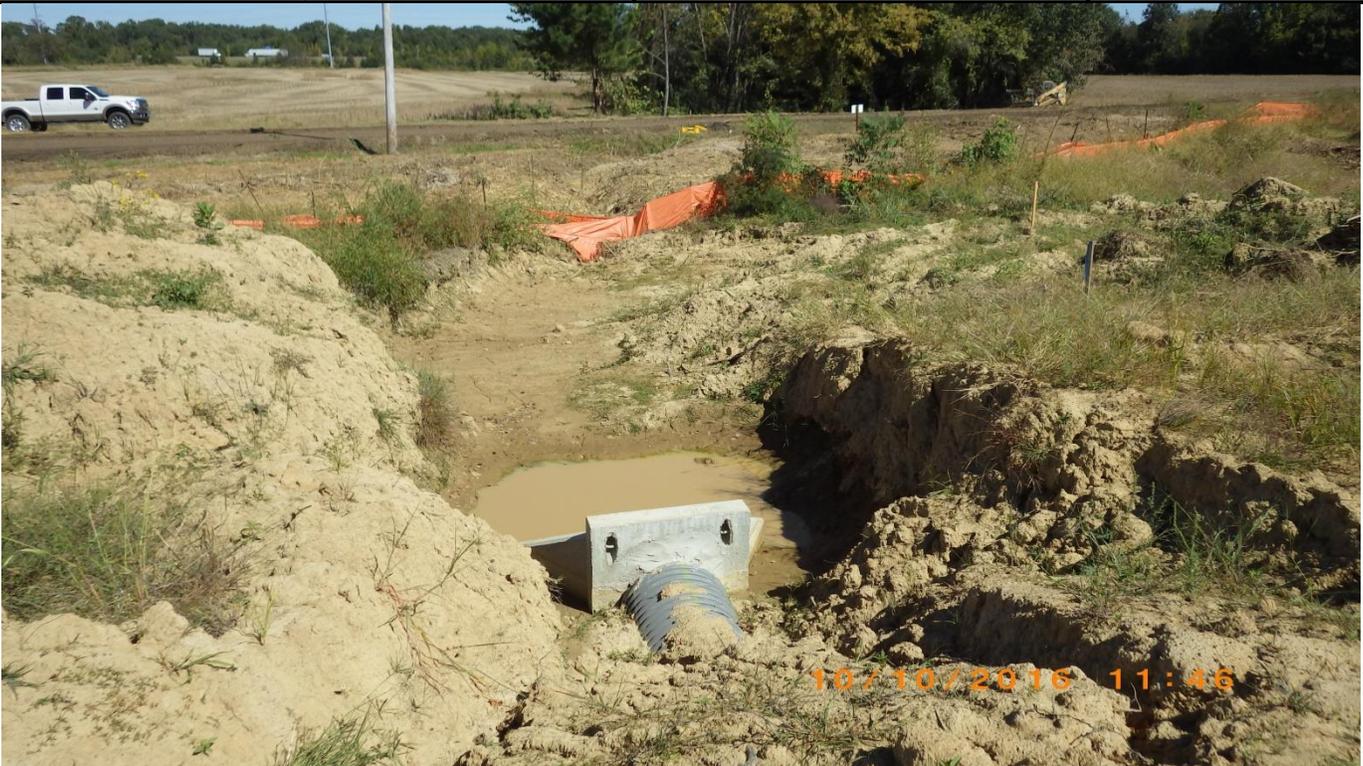
Photo 31. A puddle of turbid water was observed downgradient of the discharge outlet serving the NW sediment basin. The discharge channel had steep slopes and was not stable and no outlet protection was observed downgradient of the discharge outlet. From the maturity of the sparse vegetation on the steep slopes downgradient of the discharge outlet, it appeared that activity in this area had ceased for over 7 days and the area had not been sufficiently stabilized.

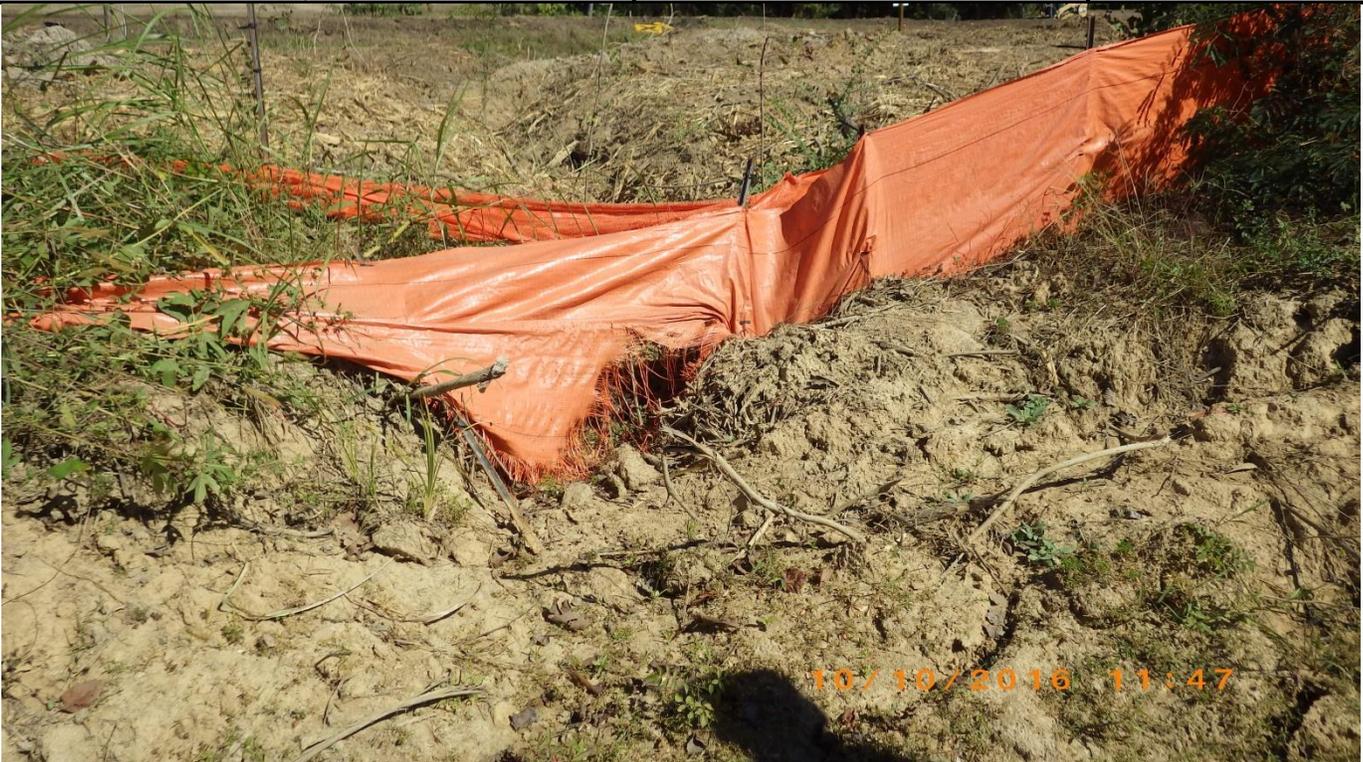
Photo 32. View facing Shelby Drive of the discharge outlet serving the NW sediment basin shown in Photo 31. The discharge channel had steep slopes and was not stable and no outlet protection was observed downgradient of the discharge outlet. From the maturity of the sparse vegetation on the steep slopes downgradient of the discharge outlet, it appeared that activity in this area had ceased for over 7 days and the area had not been sufficiently stabilized.

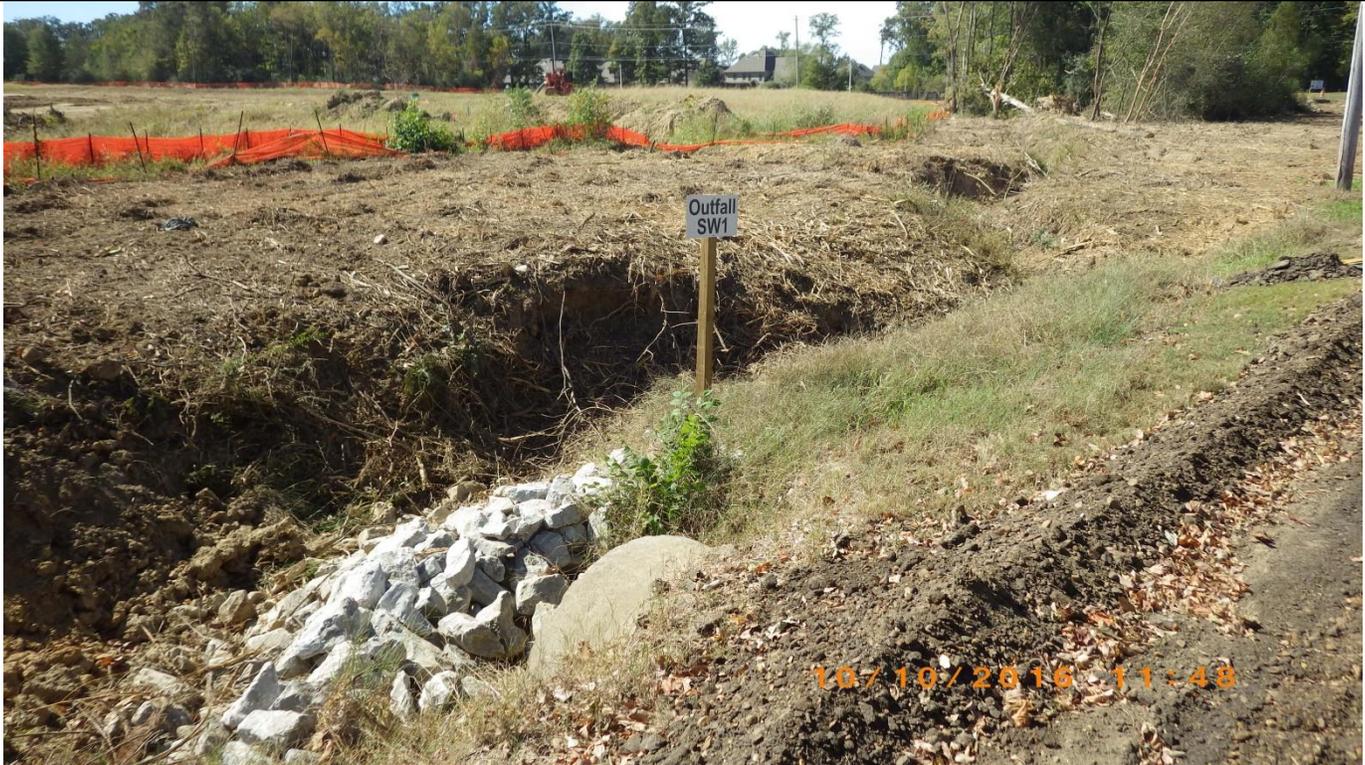
Photo 33. Silt fence had been installed across the direct flow path of the discharge channel between the NW sediment basin outlet structure and Outfall SW1. According to the *Tennessee Erosion Prevention and Sediment Control Handbook*, silt fence should not be placed in the areas of concentrated flow.

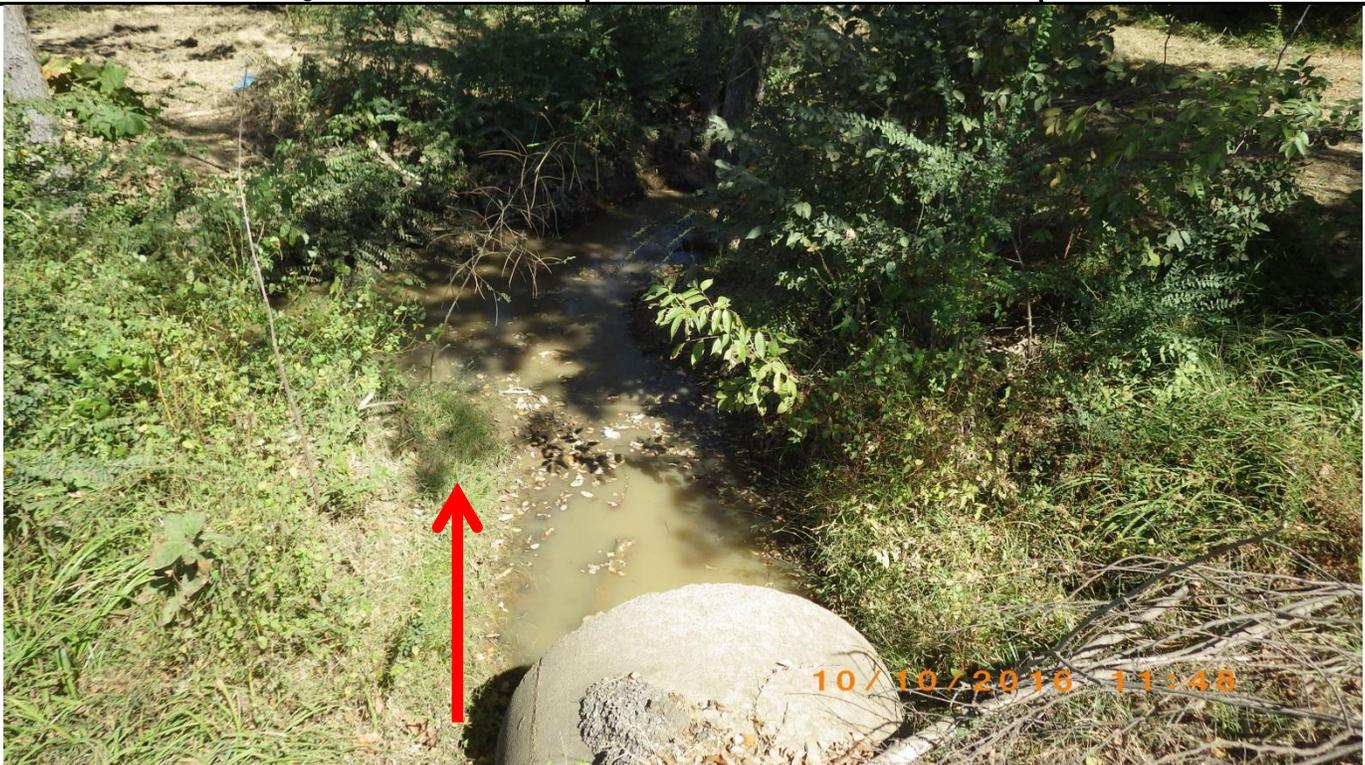
Photo 34. Sign identifying the approximate location of Outfall SW1. The drainage channel leading to Outfall SW1 was unstable and had steep banks. Stormwater from the construction site enters into the pipe shown here and flows under Shelby Drive. No discharge from Outfall SW1 was observed during the inspection.

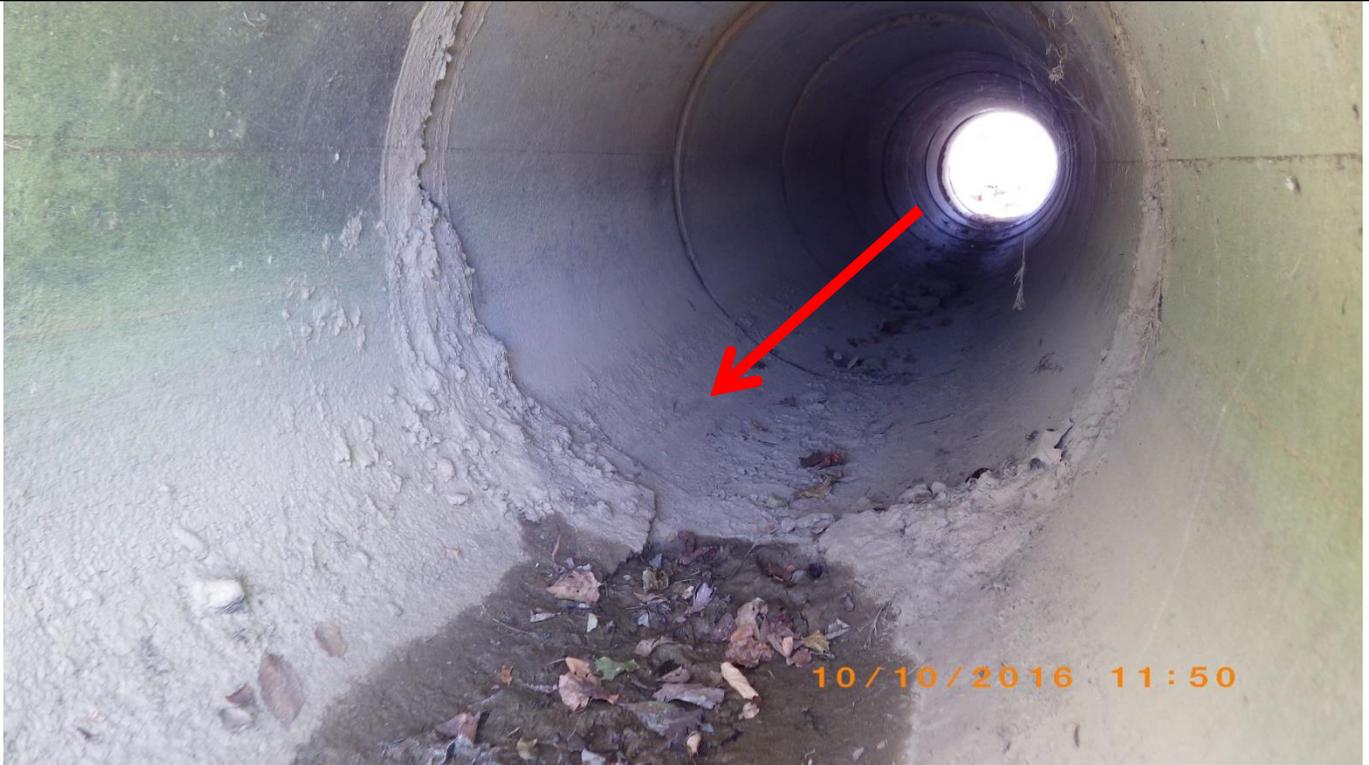
Photo 35. Slightly turbid water was observed downgradient of Outfall SW1 on the north side of Shelby Drive. The pipe visible in this photo receives drainage from the construction site through Outfall SW1. The direction of flow is indicated with a red arrow. No discharge from Outfall SW1 was observed during the inspection.

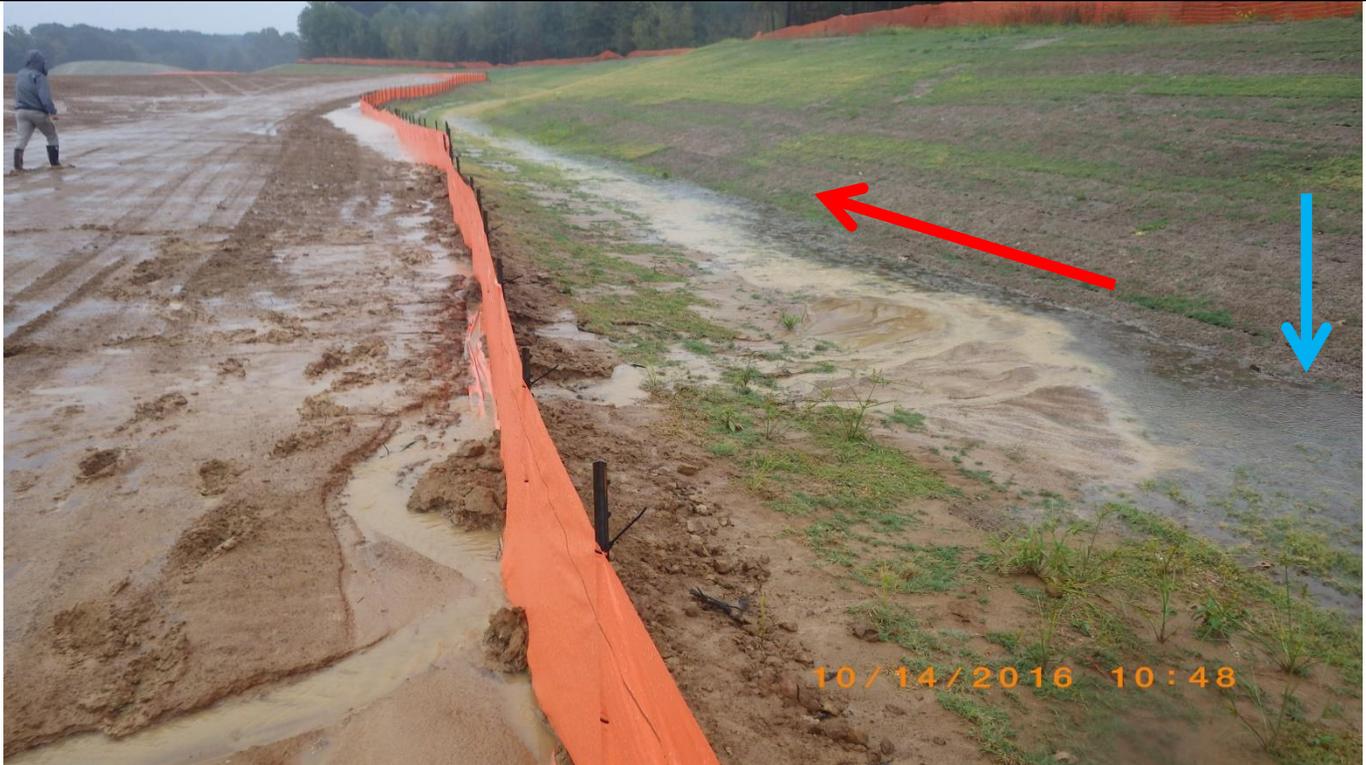
Photo 37. Sediment and sediment laden stormwater flowing under the silt fence and entering the permanent grass lined diversion ditch on the south side of the construction site. The permanent grass lined diversion ditch discharges into an unnamed tributary of Nonconnah Creek at Outfall SW6. The direction of flow is indicated with a red arrow. Note the water up-gradient of the sediment plume (blue arrow) is less turbid.

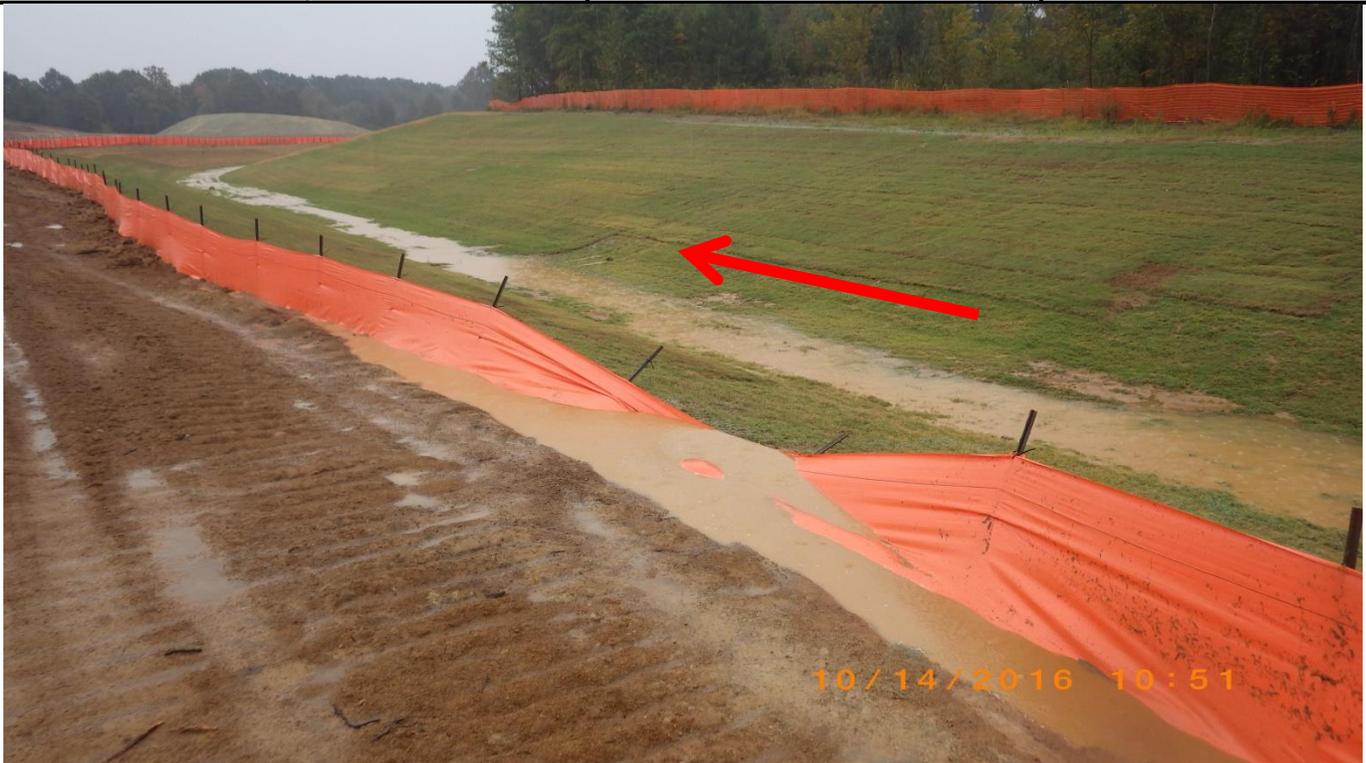
Photo 38. Sediment laden stormwater flowing over the silt fence and entering the permanent grass lined diversion ditch that discharges into an unnamed tributary of Nonconnah Creek at Outfall SW6. The direction of flow is indicated with a red arrow.

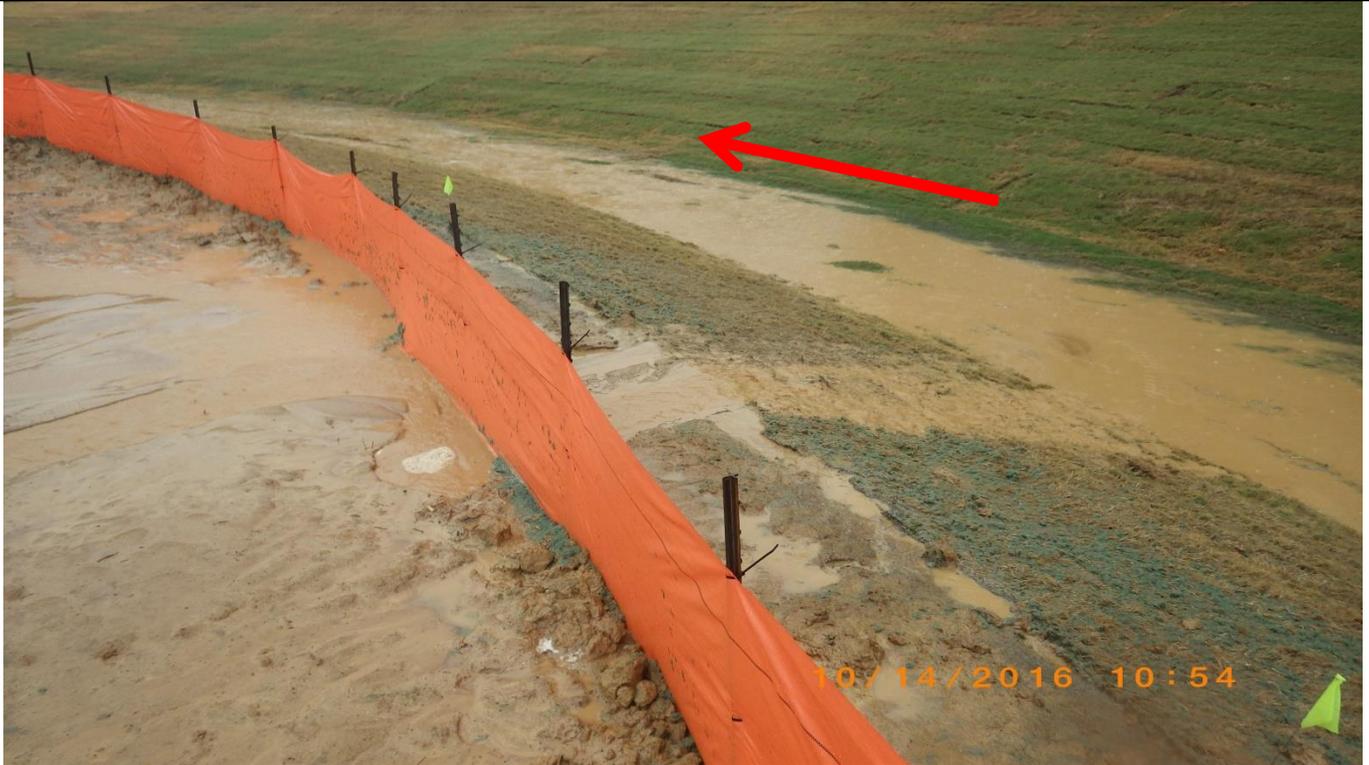
Photo 39. Sediment and sediment laden stormwater flowing under the silt fence and entering the permanent grass lined diversion ditch that discharges into an unnamed tributary of Nonconnah Creek at Outfall SW6. The direction of flow is indicated with a red arrow.

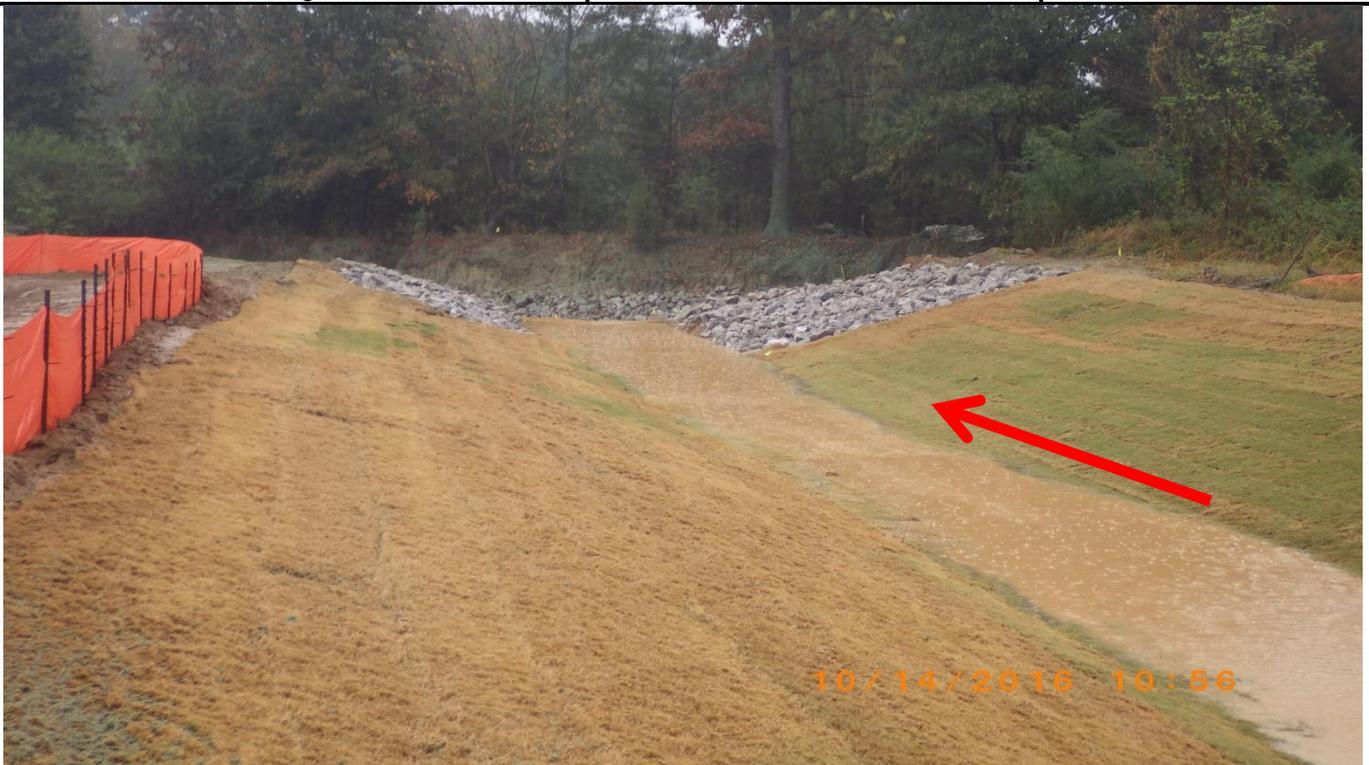
Photo 40. View of sediment laden stormwater flowing through the permanent grass lined diversion ditch to Outfall SW6. The direction of flow is indicated with a red arrow.

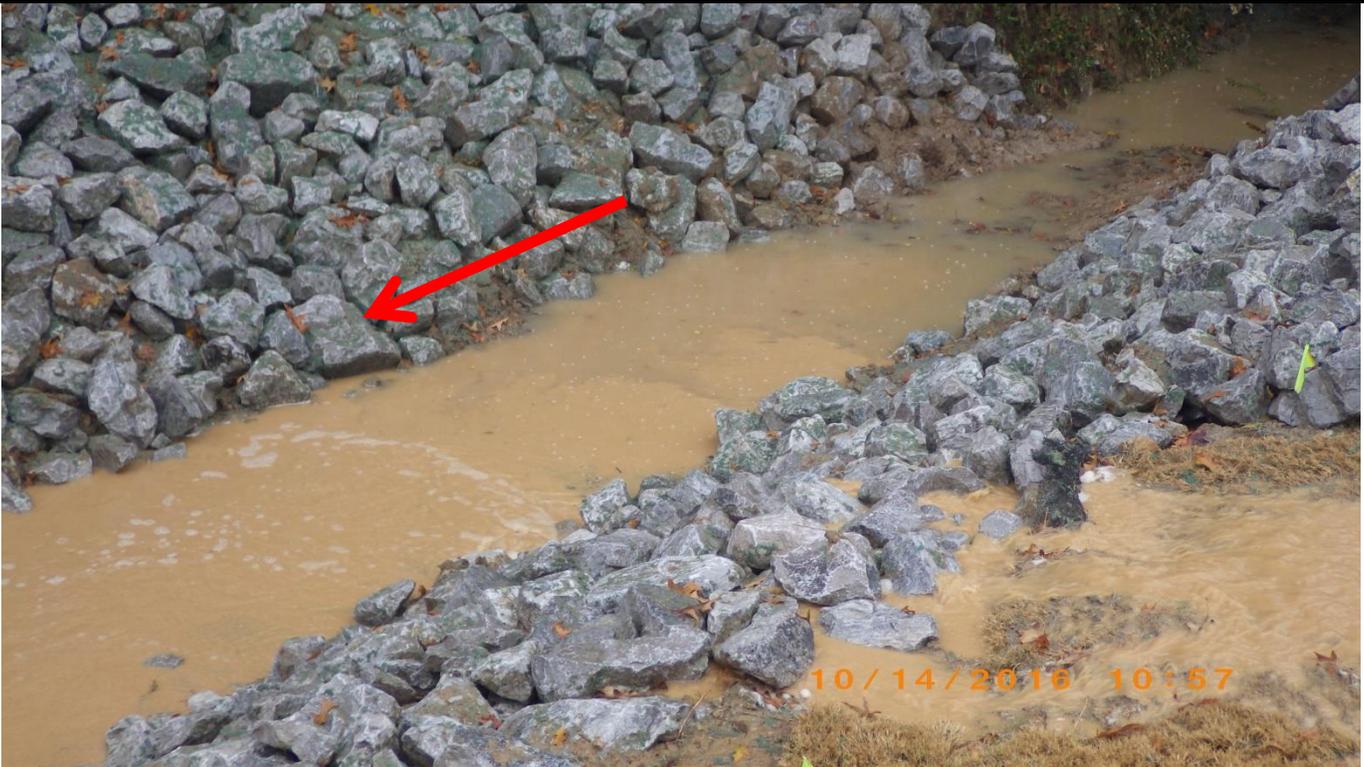
Photo 41. Sediment laden stormwater from the permanent grass lined diversion ditch discharging into the unnamed tributary of Nonconnah Creek (i.e., waters of the state) at Outfall SW6. The instream water velocity up-gradient of Outfall SW6 appeared to be slower than the water velocity down gradient of the discharge point. This is represented by the observed sediment plumes moving upstream from the discharge point, indicating the instream flow at that location was not fast enough to flush the sediment plumes downstream. It appeared that runoff from the construction site had contributed to the increased flow within the stream at the observed outfalls associated with the unnamed tributary of Nonconnah Creek. The direction of flow is indicated with a red arrow.

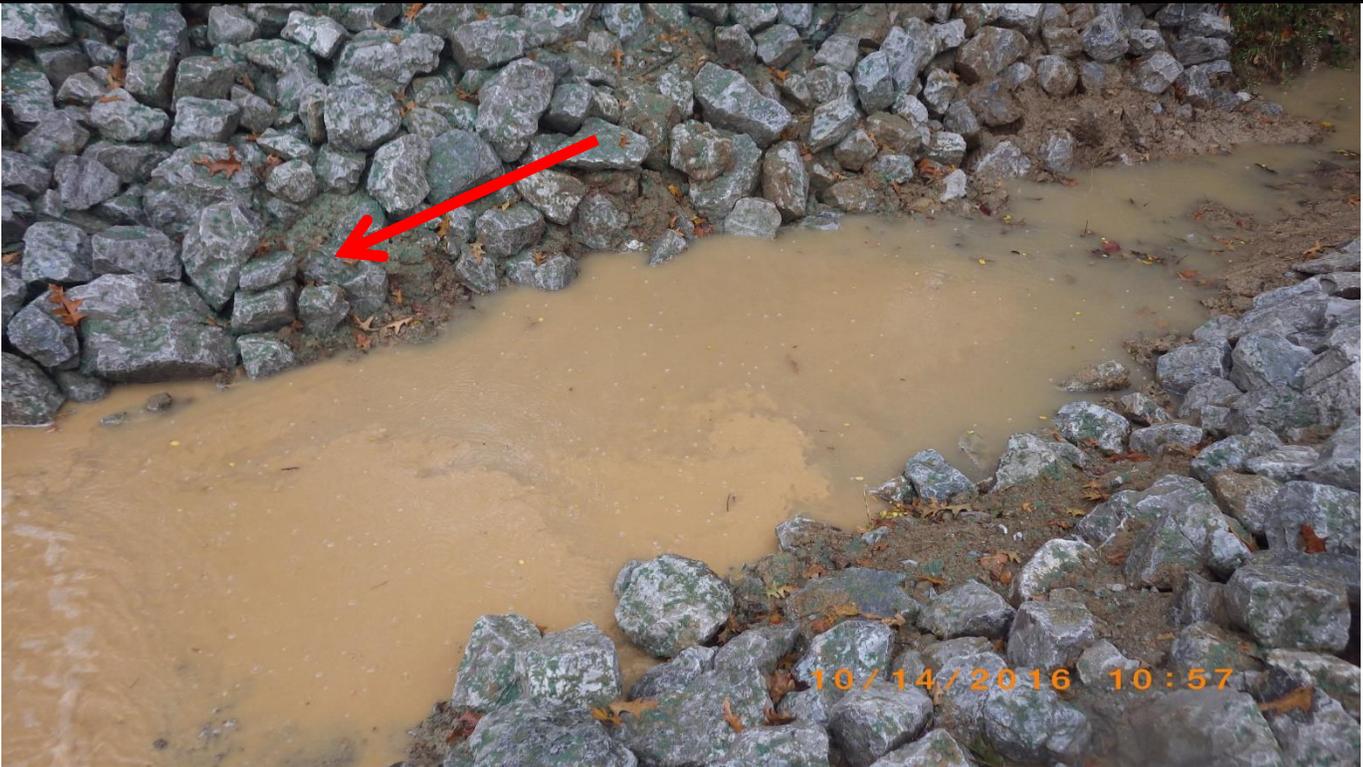
Photo 42. Close-up view of the color contrast created by the sediment laden discharge from the construction site into the unnamed tributary of Nonconnah Creek. The instream water velocity up-gradient of Outfall SW6 appeared to be slower than the water velocity down gradient of the discharge point. This is represented by the observed sediment plumes moving upstream from the discharge point, indicating the instream flow at that location was not fast enough to flush the sediment plumes downstream. It appeared that runoff from the construction site had contributed to the increased flow within the stream at the observed outfalls associated with the unnamed tributary of Nonconnah Creek. The direction of flow is indicated with a red arrow.

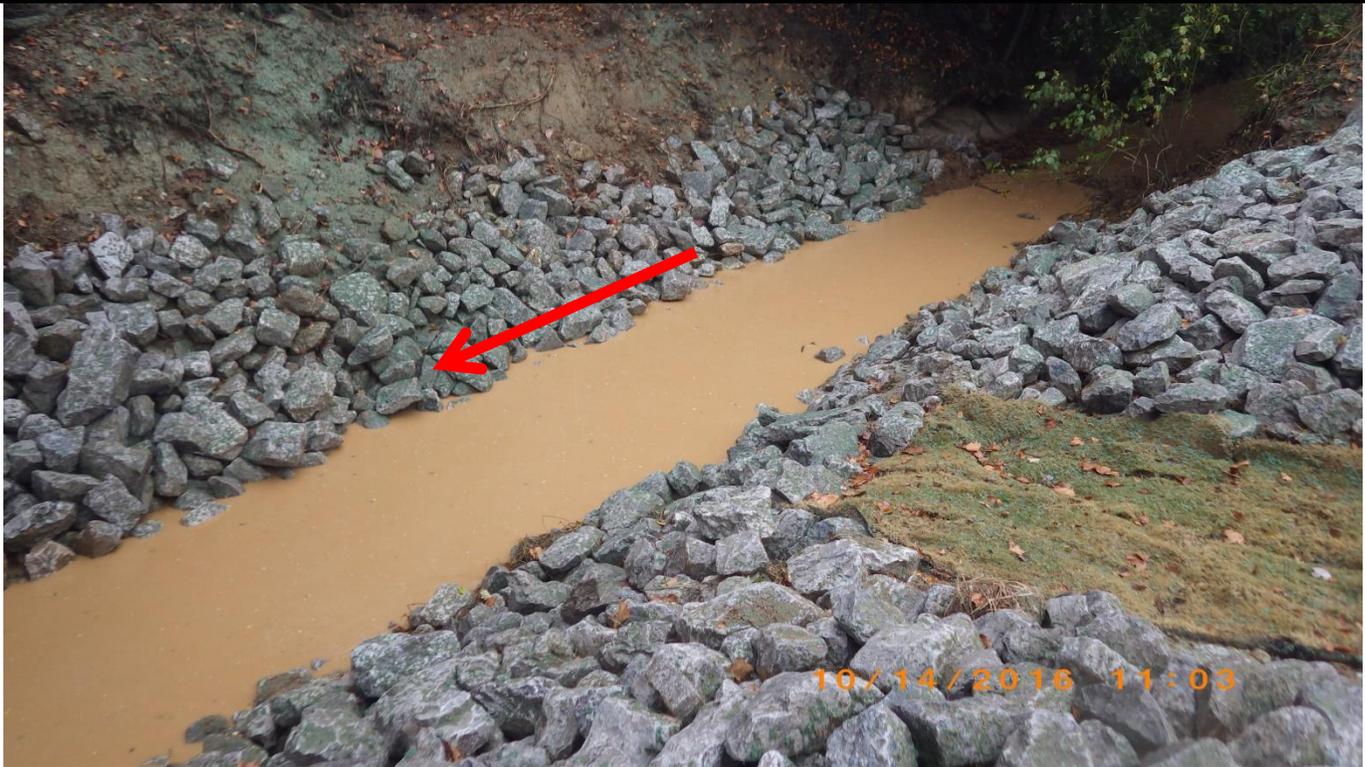
Photo 43. No discharge was observed at Outfall SW7; however, the water in the stream at this location was very turbid. Outfall SW7 is located downstream of Outfall SW6. The direction of flow is indicated with a red arrow.

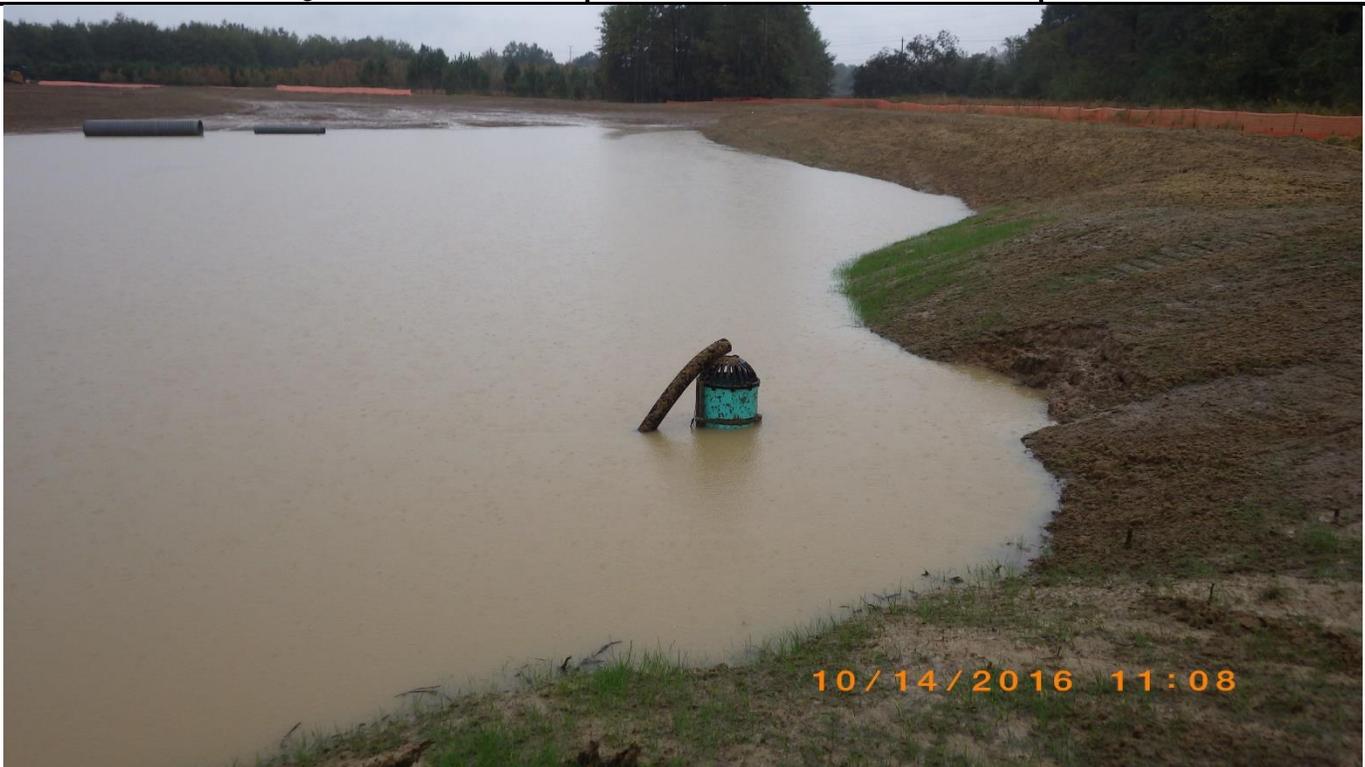
Photo 44. View of the riser structure serving the NE sediment basin. The water level in the basin was much higher than during the previous inspection on October 10, 2016 (Photo 10). In addition to receiving stormwater runoff from the occurring rain event, the existing farm pond was dewatered into the stormdrain system that discharges into the NE sediment basin (Photos 8 and 9). The required water depth gauge within the basin had not been installed.

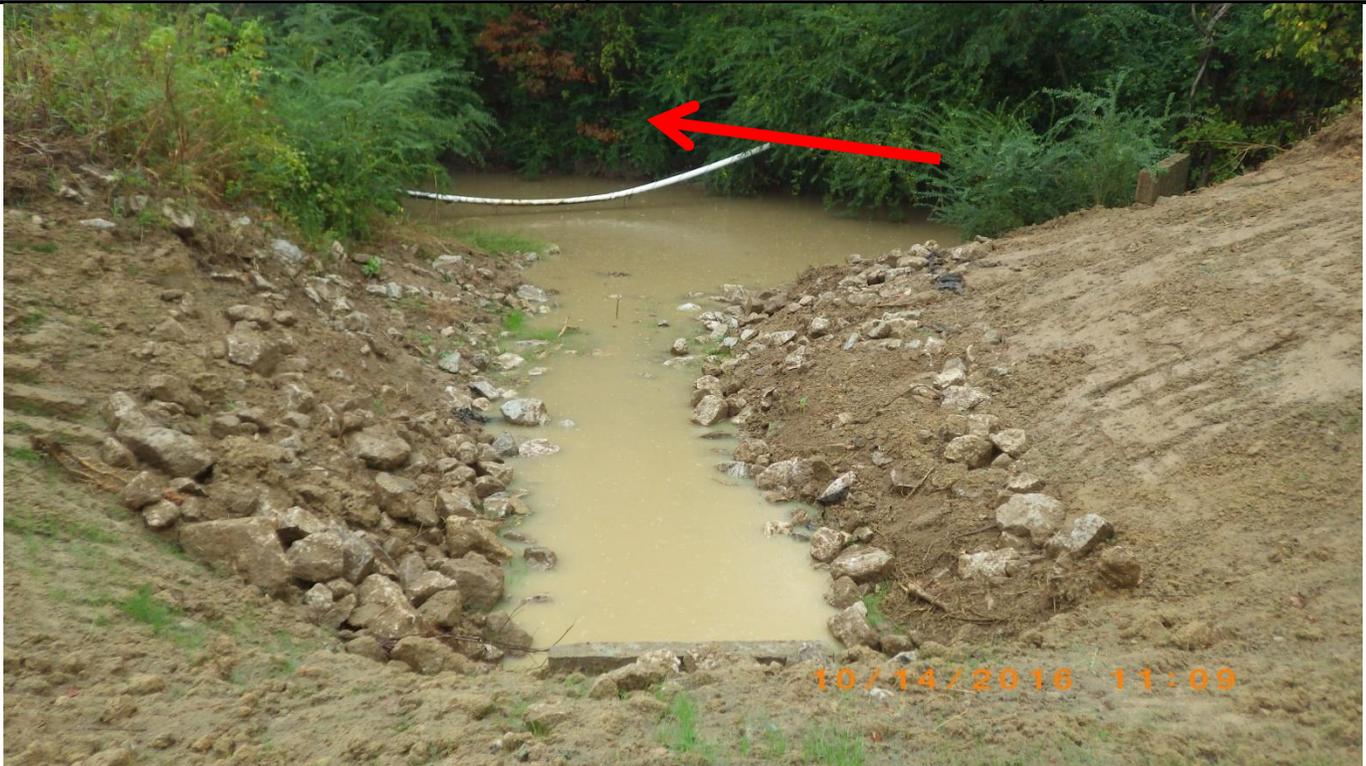
Photo 45. There was no discharge observed from the NE sediment basin at Outfall SW4, but it appeared that the water elevation in the unnamed tributary of Nonconnah Creek was high enough to backflow into the discharge channel that serves the NE sediment basin. The direction of flow is indicated with a red arrow.
